CONDITION SURVEY, HUNTER ARMY AIRFIELD SAVANNAH, GEORGIA

A. H. Joseph
P. J. Vedros
W. B. Abbott, Jr.

August 1969

U. S. Army Engineer Waterways Experiment Station
CORPS OF ENGINEERS
Vicksburg, Mississippi

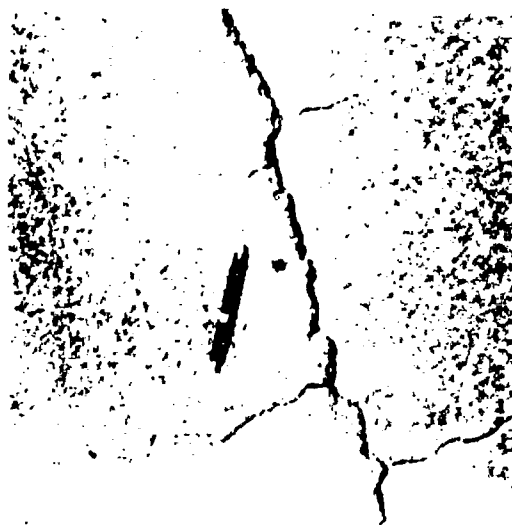
12. Prior to placing the material, the existing asphaltic-concrete surfaces were scaling and cracking, with some cracks as wide as 1/2 in. These surfaces had been sealed 8 to 10 years ago with a tar seal, and the latter material was scaling from the surface. Photographs 2 and 3 show the condition of the pavement surface in an area that was not treated and indicate the general condition of the surface prior to application of the bituminous pavement coating.

Photograph 3. Typical cracks in
untreated pavement

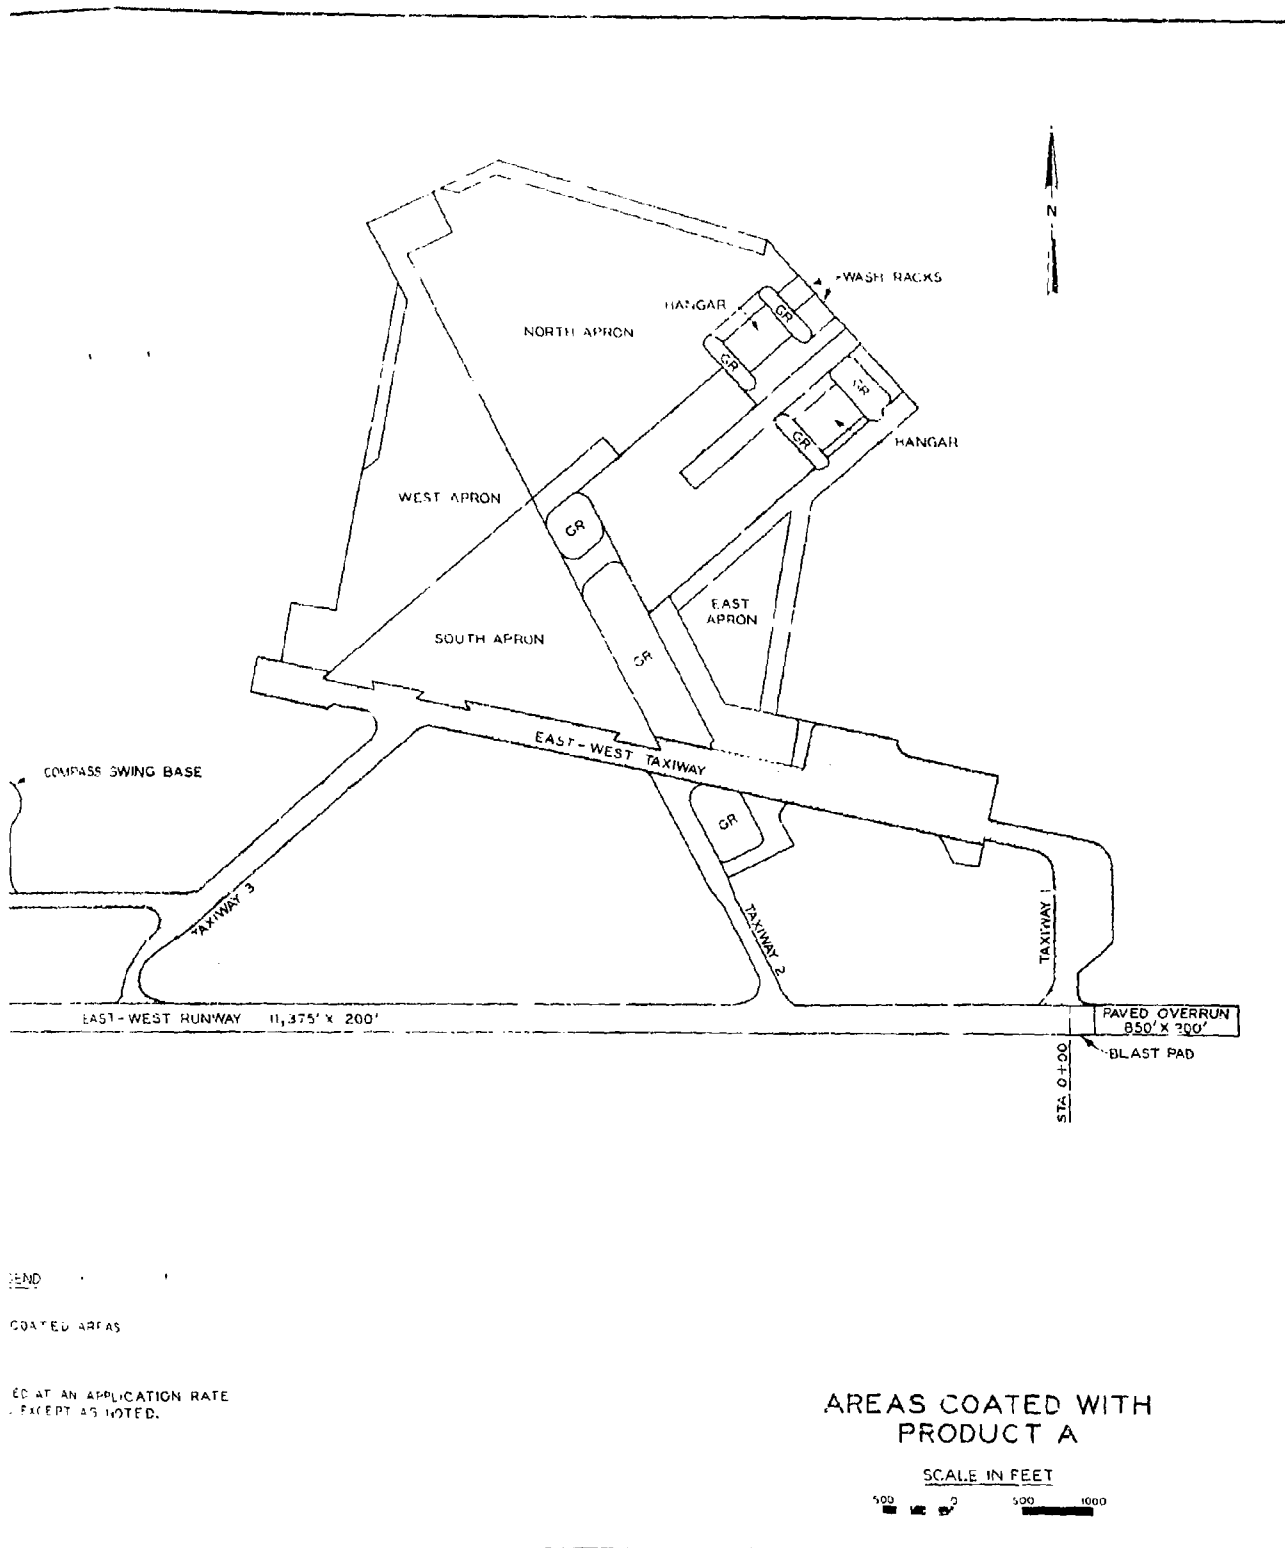
AREAS COATED WITH PRODUCT A

11. A bituminous pavement coating material (Product A) was used extensively on HAAF's existing asphaltic-concrete taxiways, aprons, and shoulder areas for adhering loose pavement particles and sealing the aging surfaces. The airfield pavements that were coated during the period between May 1967 and May 1968 are shown in plate 4. This proprietary material is primarily a combination of a fast-drying solvent and a hard-base asphalt.

13. Product A was sprayed on the asphaltic-concrete surface at a rate of 0.2 gal/sq yd. There was one exception to this. A portion of the warm-up apron on the west end of taxiway 5 was treated at a rate of 0.3 gal/sq yd (plate 4). This small section was reported to contain more cracking in the surface, and this was the reason for the heavier application.
